# Building and Environment Assessment of Dr. H. Mezger School Melela

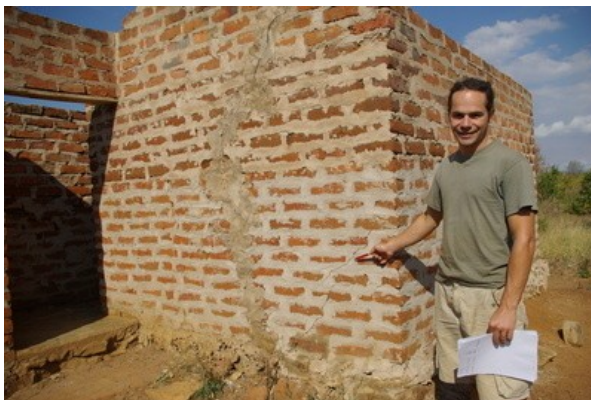
There are cracks in the bricklayer wall of the student's toilet building (see Figure 1 and Figure 2). Furthermore the floor sunk down in some parts.

These problems are obviously caused by improper constructed foundations at the north-east corner of the building (compare Figure 3)

Figure 1: Cracks in girls' toilet building

The building parts which are not signed as affected in Figure 3 are still in a good general condition. Therefore it is recommendable to repair the occurred effects instead of rebuilding the complete building (unless the toilet building should be lifted on a higher standard or have to be bigger because of the increasing number of students). For the repair works the affected walls must be disassembled and the foundations must be reinforced or completely changed in the affected area.

Furthermore it is important to complete the building with an appropriate roof. This work should be completed before the common raining season starts. Otherwise there are further damages on the walls and the floor likely.

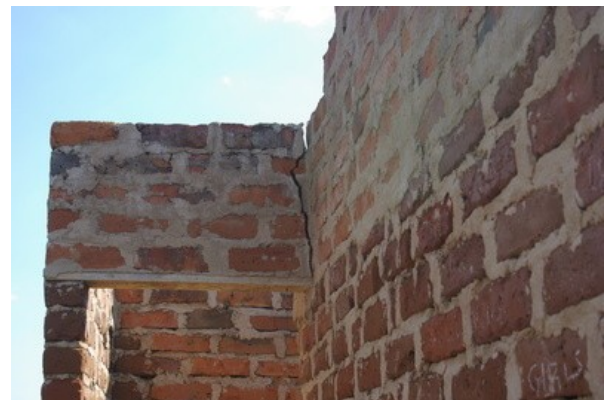
Figure 2: Crack at girls' entry

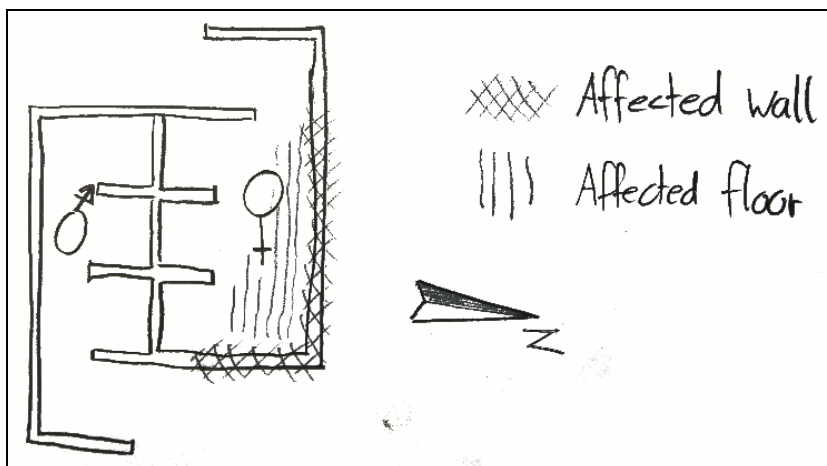
**Figure 3:** Ground view of student's toilet building

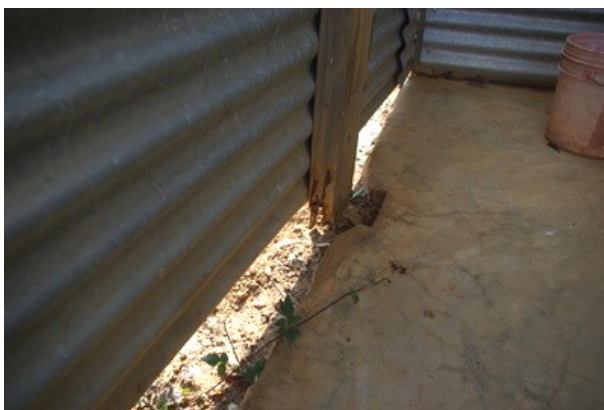
**Figure 4:** Damage at vertical timber member

Figure 4 shows the damaged lower part of the vertical timber member. This damage occurred because the timber was exposed to the weathering and to insects and fungus (mushrooms). As general building rule to prevent such faults at further buildings it is important to locate vertical timber members at least at a height of 30cm. This can easily be achieved by using concrete sockets with this height. Neither splashing water nor soaking water will then affect the timber member.

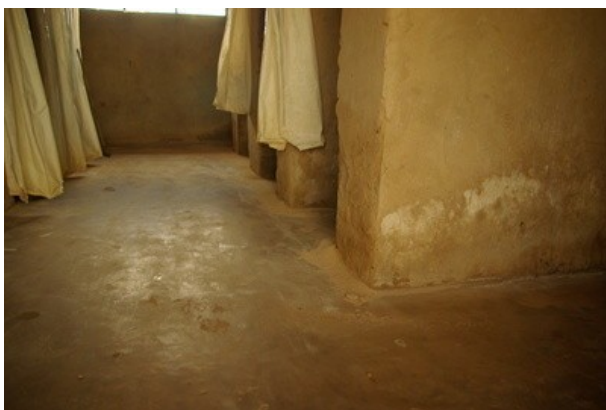
**Figure 5:** Washing room at boys' dormitory    **Figure 6:** Floor at washing room

The floor and the walls at the boys' washing room are partial damaged. This damage is caused by water exposure and by mechanical effects (dropping of things etc.). The damages are worse at the walls and limited at the floor although the water remains for longer time on the floor during usage. Obviously the used material for the floor is a higher quality. To prevent further damages the walls must be protected from the water influence. Appropriate paintings are a good and economic way to protect the walls.

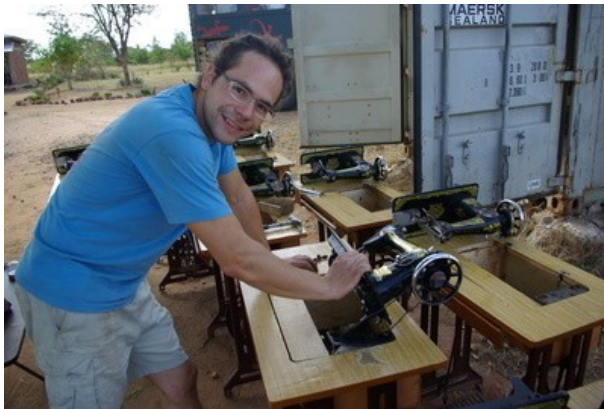
Figure 11: Repair work

The problems of the machines occurred out of two reasons:

- Exposure to the weather; parts of the machines were oxidised (rusted), moving parts didn't work any more.
- The small and easy to remove parts were missing. Got they stolen? The persons working on the machines should be responsible for them and make sure that nothing is missing. It took us a lot of time to get all the parts in the shops, at the end we spent the money worth half of a brand new machine only for missing parts!

After about 5 days of work on the sewing machines we managed to fix 10 out of 11 machines. They are now ready for usage.

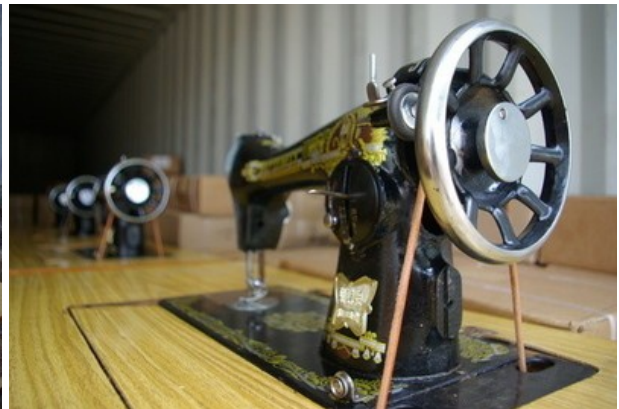
Figure 12: Fixed sewing machines
