# Building and Environment Assessment of Dr. H. Mezger School Melela

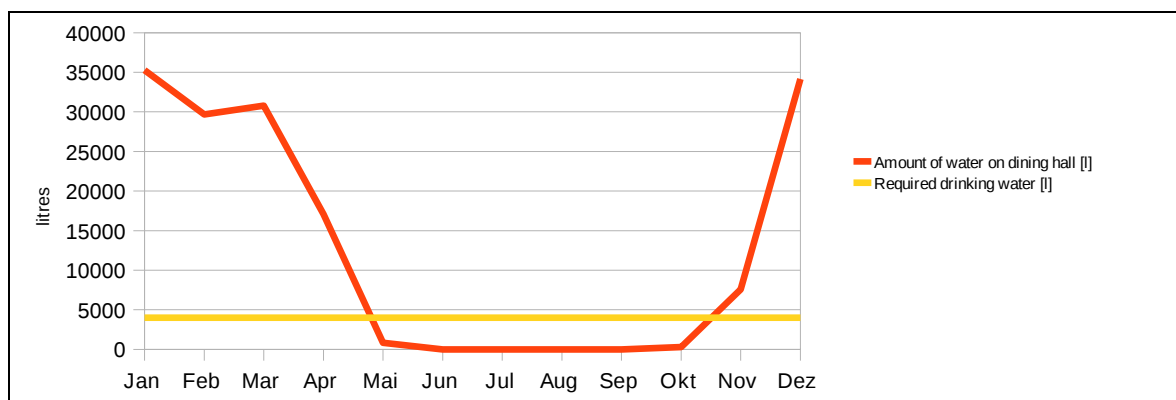
**Figure 7:** Rain water and drinking water

Getting exact data of the weather and rain in Melela is not very easy. Figure 7 is based on the climate data of Dodoma. The red curve shows the possible rainfall on an area with a size of 280m<sup>2</sup>. This is equal to the roof area of the dining hall.

The yellow line shows the current consumption of drinking water (1000 litres per week).

The amount of rain falling on the dining hall is 3 times bigger than the consumption per year. During almost 6 months the rainfall is smaller than the consumption.

To store water for full year usage there would be a need of approximately 24 000 litres capacity of water storage. Please remember that such a big amount of water must be conserved adequately. This is probably only with chemical additives possible because the water is getting quite hot in black polytanks.

To buffer water as drink water supply during the rain season a capacity of 2 000 litres would be sufficient if there is a strong rain event once in two weeks time or one midrange rain once in a week. According own experiences this should be very likely.

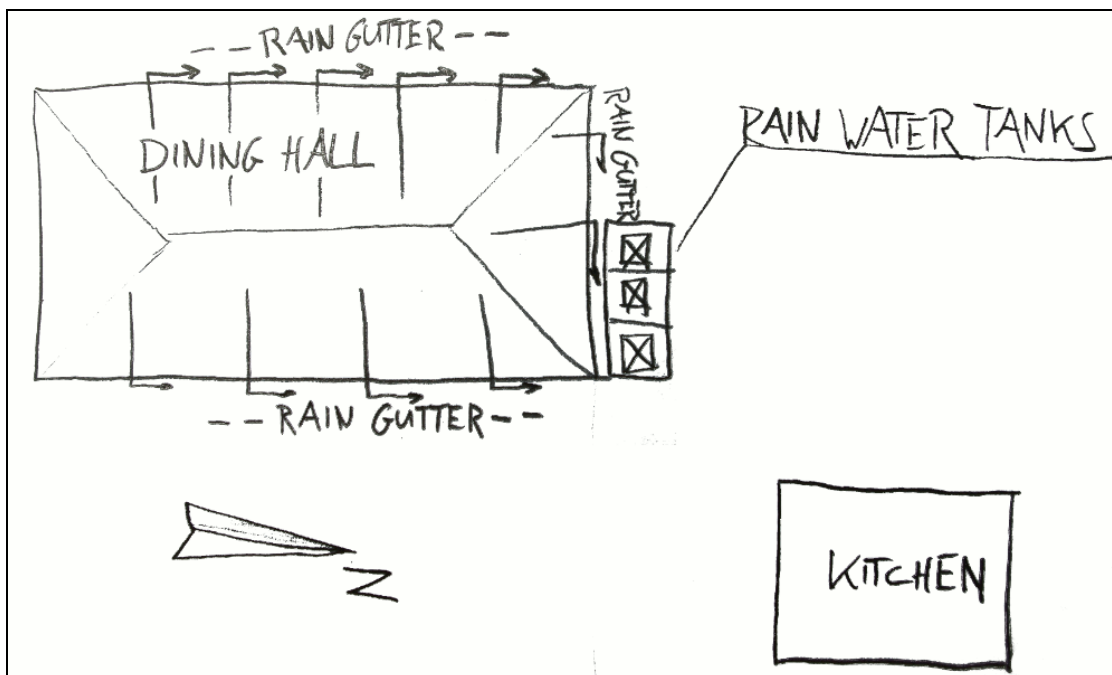
Figure 8: Ground view of possible rain water supply

Figure 8 shows a possible location for the polytanks for the rain water storage.

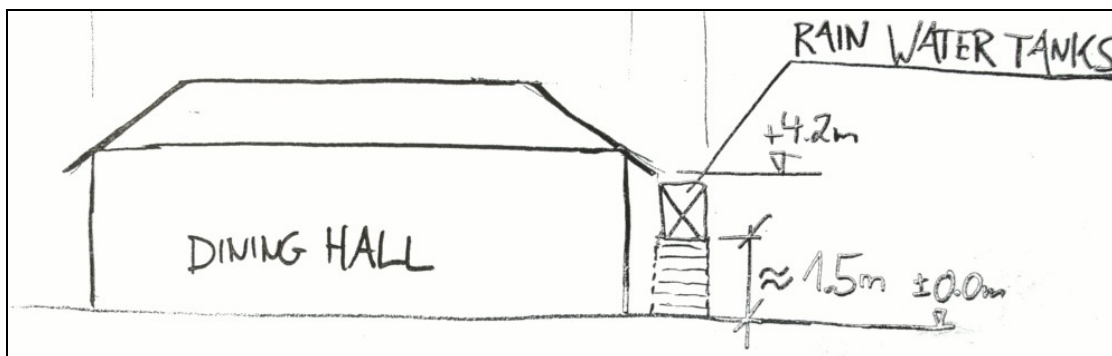
Figure 9: Side view (East) of possible rain water tanks

Below in Figure 9 one can see a possible elevation. The chosen place is so far not occupied by other building parts and furthermore the filling a well as the emptying can be achieved without using any pumps.

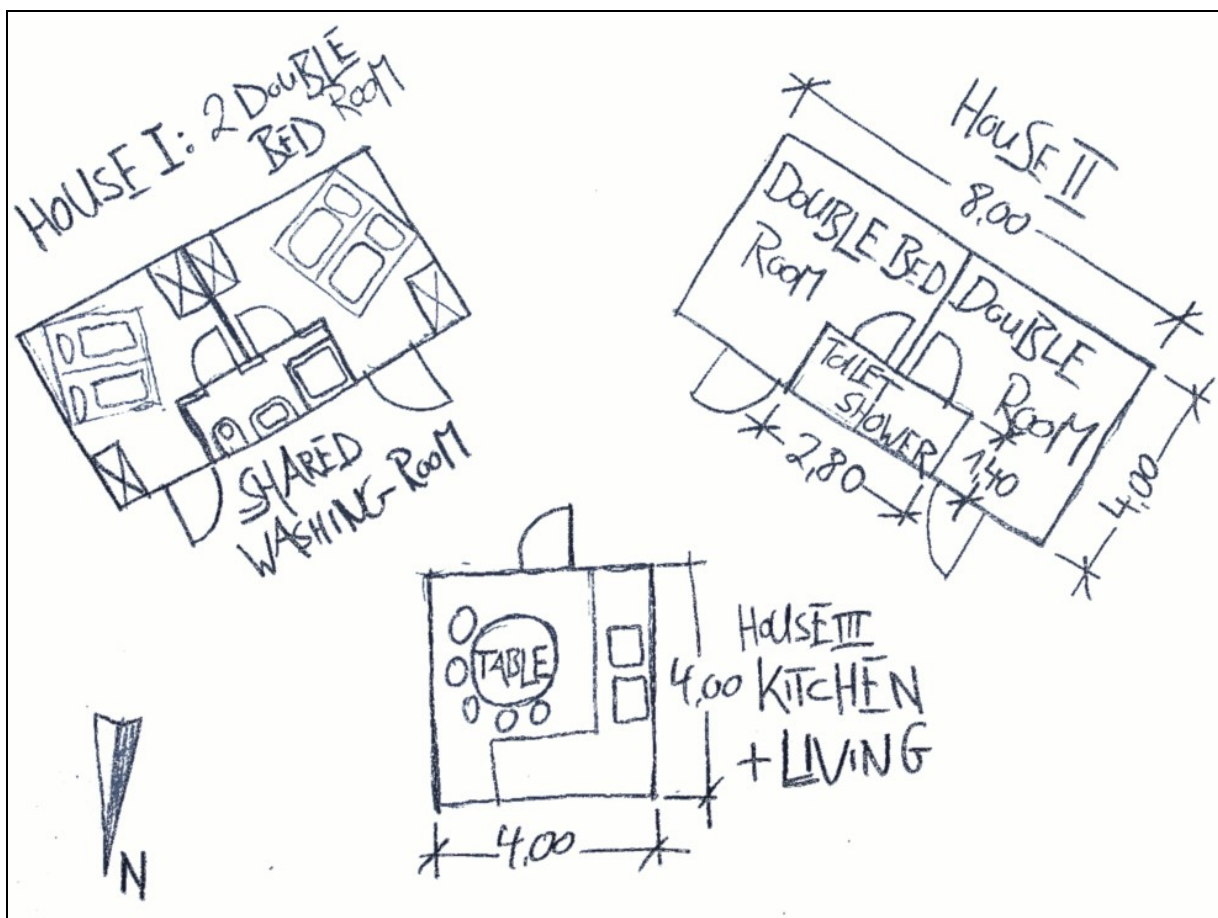
Figure 10: Possible arrangement of the guest house buildings

The Figure 10 shows a possible arrangement of guest houses. The idea is that there is one shared bathroom for two double bed rooms. In this case the houses can either used by one family each or even by two independent parties. Furthermore we assumed to have a third building which accommodates a kitchen and living room in one. According own experiences people meet were there is food ;-)

The advantage of this solution is the fact that there is space for privacy as well as for the commune. Because of the limited size of the houses it may be built by using simple construction methods. We recommend to use bricklayer walls with open windows without glass and a timber roof structure with metal decking. These are common methods of construction in the area and are comparably cheap and good.

For water supply a polytank on the top of the kitchen building is considerable and the electricity could be produced by using a PV system.
